ANNOUNCEMENT

#402

Chrysler Oil Filter Replacement Notice

Oil Filter Housing Cap	Associated Oil Filter
OE# 68191350AA	100010 / 2100010

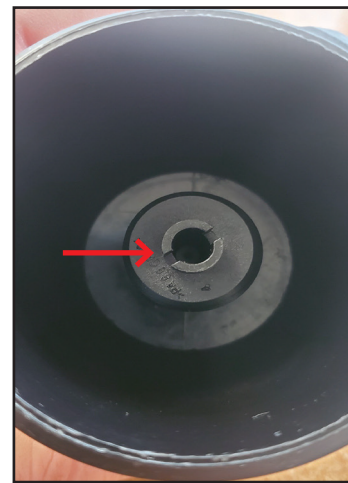
It has been identified that over time, the pressure relief valve located in the housing cap (Chrysler OE Cap P/N: 68191350AA) can detach from the housing cap and migrate up the center tube of NAPA oil filter 100010 / 2100010 (more common in cold weather conditions).

ENHANCED DESIGN: To prevent this failure mode, NAPA redesigned the filter with integrated rails in the center core that will capture the relief valve poppet if relief valve failure occurs. The valve will only be able to move a quarter of the way up the center core, ensuring it does not reach the top where it could obstruct oil flow. This prevents engine failure due to oil starvation.

- Technicians and vehicle owners should inspect the oil filter housing cap during routine oil changes.
- If any signs of damage, cracking, or a loose relief valve are detected, replace the housing cap immediately.
- Service centers should inform customers of the potential issue and offer HOUSING CAP replacement options.

- It is highly recommended to replace the housing cap every 3–4 oil changes or every 30,000 miles to prevent failure.
- Always use a high-quality OEM equivalent replacement part.

- Pull the oil filter housing cap straight from the filter. Do not rock the filter back and forth to release the housing cap as damage can be caused to the housing cap bypass valve. In these cases, the housing cap would need to be replaced.
- When uninstalled from the housing cap in a harsh manner, the bypass valve can be damaged and/ or broken.

- Ensure the oil filter housing cap is tightened to the manufacturer's specified torque value.
- Over-tightening can cause cracks and potential failure of the housing cap.

This is not a defective oil filter. It is a malfunction of the oil filter housing cap. Carefully inspect the housing cap before installing a new oil filter. If the by-pass valve is missing, broken or damaged, replace the housing cap. By implementing these preventive measures and utilizing the enhanced filter design, the risk of oil starvation and subsequent engine failure can be significantly reduced.
