ANNOUNCEMENT

PGI ENG DOC 381

Mopar Oil Leak - 2.0L & 2.4L Engines

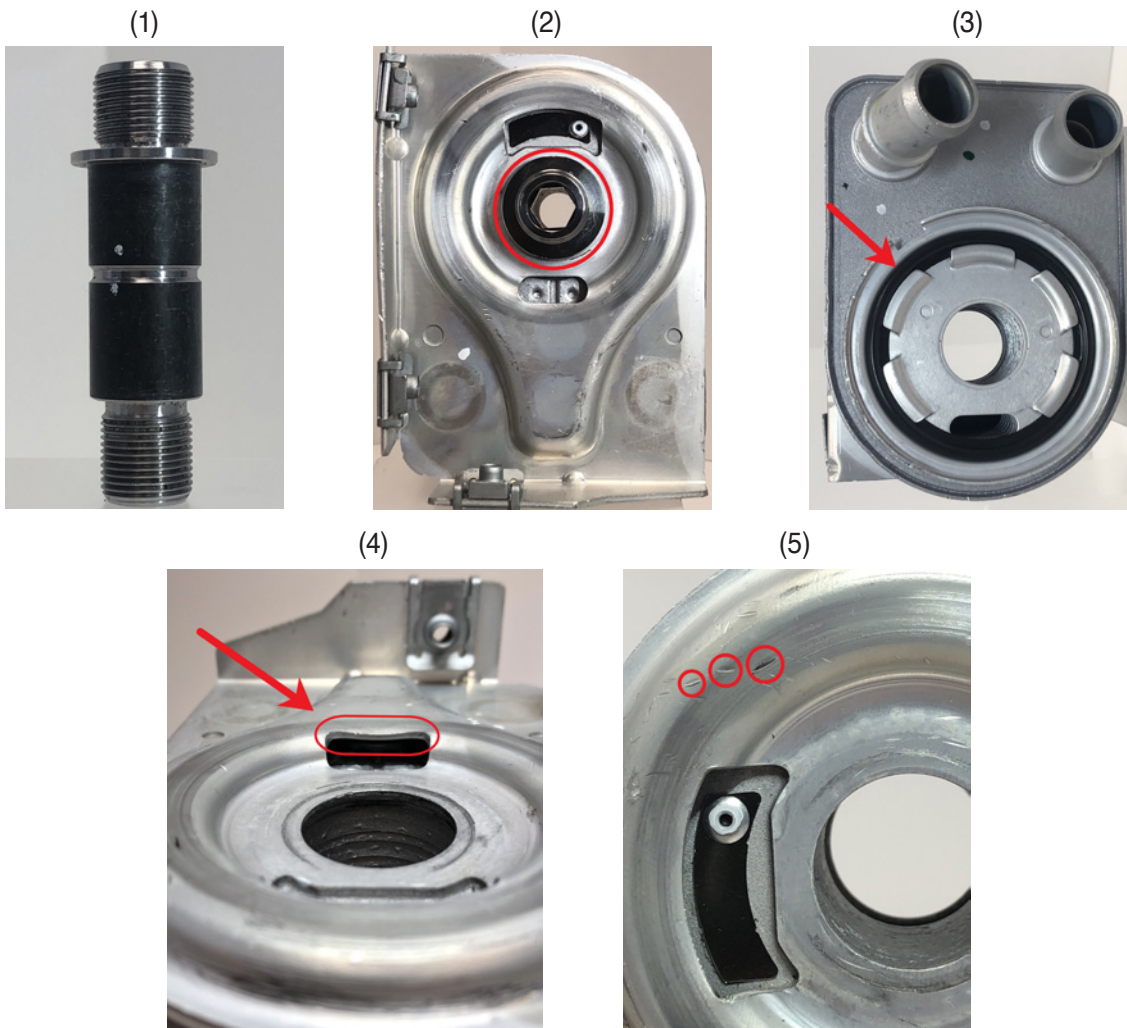
In recent months, there have been reports of 7060, 7060MP, 27060, and 27060MP filters leaking when installed on Mopar products. Specifically models with 2.0L and 2.4L engines, these vehicles may experience a slight oil leak from the engine due to a leaking oil cooler O-ring, damaged oil cooler, or loose oil cooler connector bolt. Leaks may occur after an oil change because the oil filter is attached to the oil cooler.

1. Verify the oil cooler connector bolt is torqued to the factory specifications. FIG (1) (2)
2. If the connector bolt is found improperly torqued, inspect the oil cooler sealing O-ring for damage. FIG (3)
3. Inspect the oil cooler filter mounting surface for damaged or deformed surfaces. FIG (4) (5)

If any damage is observed, replace the damaged part.
