PRODUCT QUALITY BULLETIN

#518

NAPA Oil Filter 7938 O-ring Differences

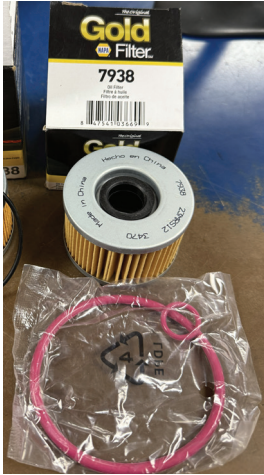
The O-ring provided with Napa 7938 could be incorrect size. Please see below the wrong packaging on the left and the correct on the right.

<p style="text-align: center;">7938</p> <p style="text-align: center;">Incorrect O-ring</p> <p style="text-align: center;">O-ring 1 ID and Thickness - 3" x 3/16" O-ring 2 ID and Thickness - 0.6" x 3/32"</p>	<p style="text-align: center;">7938</p> <p style="text-align: center;">Correct O-ring</p> <p style="text-align: center;">O-ring 1 ID and Thickness - 3" x 3/32" O-ring 2 ID and Thickness - 0.6" x 3/32"</p>

If you find that any of the 7938 has the wrong O-rings in package, please dispose and request SDG90211K for a replacement O-ring pack. Please contact your sales representative to request this replacement.
