INSTALLATION ALERT CHECK OIL FILTER ELEMENT FOR LOOSE COMPONENTS PRIOR TO INSTALLATION OF NAPA GOLD 100521, 100514 OR 2100514

NAPA Gold[®] **100521** (Hyundai 26350-2J000) and **100514/2100514** (Hyundai 26350-2S000) are shipped with multiple components in the box: Oil filter, Oil filter housing cap gasket, Oil filter housing cap drain plug, and Oil pan drain plug gasket.

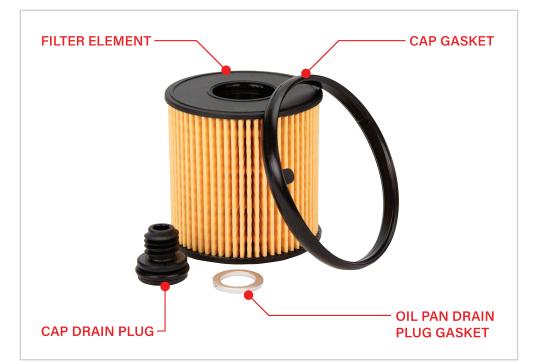
In some cases, the oil filter housing cap drain plug can become stuck inside the filter element during shipping and handling. The service technician then unknowingly installs the filter element into the housing with the drain plug still inside, *resulting in obstruction of oil flow and catastrophic engine failure.*

Before installation, verify drain plug is not misplaced inside the oil filter!

Previous Technical Service Bulletins from Hyundai encourage installers to carefully inspect the filter element to ensure that the drain plug is not inside before installation. NAPA also recommends this for any 100521 and 100514/2100514 inventory you may already have on hand.

- 1. Implemented a running change at our factories, which places the oil filter cap drain plug in a plastic bag along with the silicone gasket and oil pan drain plug gasket. This change will ensure that no kit components will become stuck in the filter element prior to installation.
- 2. Added a note to the inner flap of the unit box, alerting the installer to the possibility that the cap drain plug could be stuck inside the filter element.
