PRODUCT QUALITY BULLETIN

#518

NAPA Oil Filters: 7938, 4938, 4939
O-ring Differences

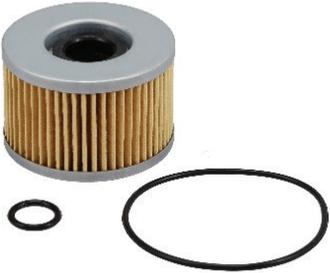
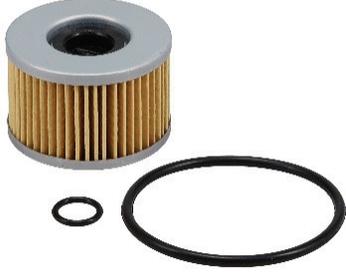
O-ring in package could potentially be wrong. Please see attached 3 photos of each number and the respective O-rings that are included.

<p>7938 O-ring 1 - 75x2.5mm O-ring 2 - 15x2.5mm</p>	<p>4938 O-ring 1 - 80x4.45mm O-ring 2 - 15x2.5mm</p>	<p>4939 O-ring 1 - Square Gasket O-ring 2 - 15x2.5mm</p>

Dispose of wrong O-rings and PGI will send the correct number of O-rings needed to replace.
Request VDM for replacement O-rings.
